Manhole Inspection Summary

Manhole # S21CC_022MH

Insp Date: **10/22/07 1:42 PM**

Location Address: **1110 MONROE ST**

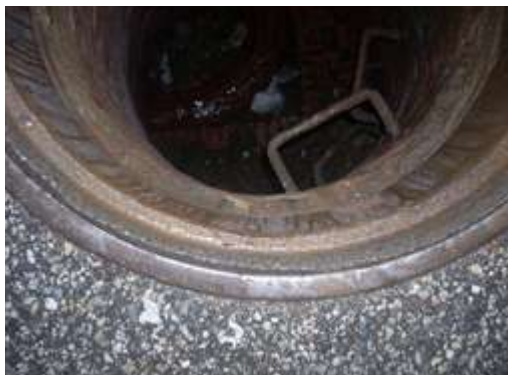
Defect 6

Frame Offset: **0.5** (in.) Condition: ☒ Sound ☐ Cracked ☐ Leaks

FRAME OFFSET

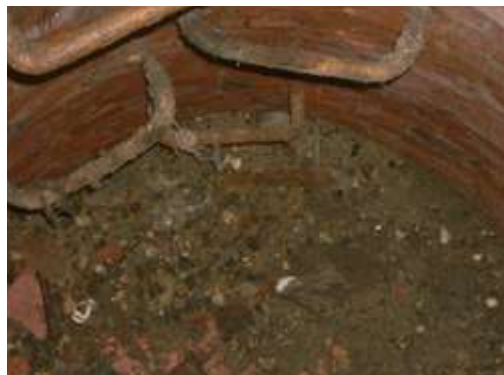
Defect 5

Surcharge ☒ Evidence Of Surcharge Depth: **5** (ft.) ☐ Active Surcharge Present

SURCHARGE EVIDENCE ON STEPS

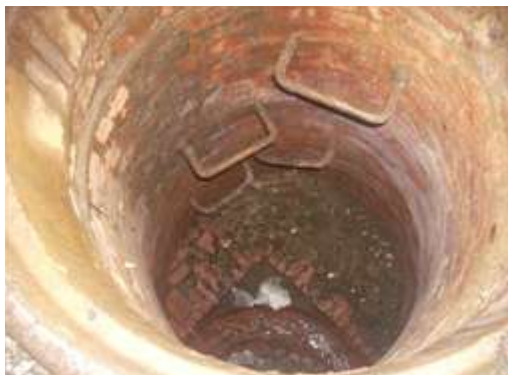
Defect 4

Steps Count: **6** Missing: **0** ☒ Corroded

CORRODED STEPS

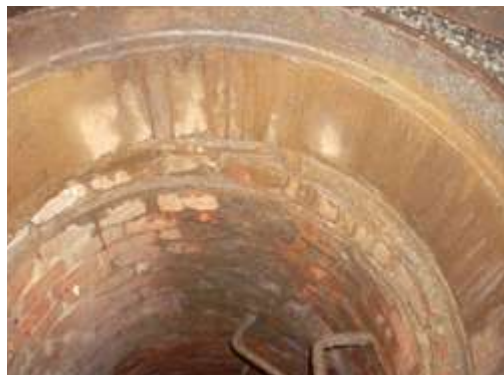
Defect 7

Infiltration: ☐ None ☐ Joint ☐ Cracks ☐ Mortar ☐ Roots ☒ Wall

CHIMNEY AND CORBEL INFILTRATION

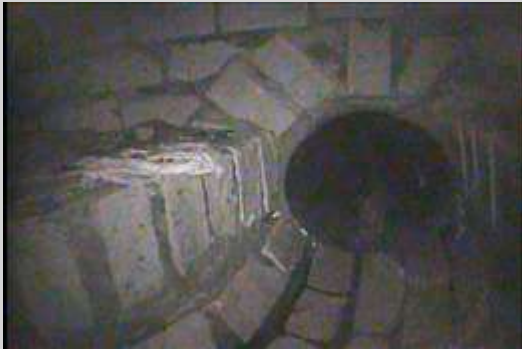
12 O'Clock Outflow

8 in. Circular Gravity Sewer
Pipe Out @ 12 O'Clock

Pipe Height: **8.4** (in.) Rod and Bar (Angled)
Pipe Material: **Clay** ☐ Pipe Lined
Invert Depth: **9.06** (ft.) Flow Characteristics: **Slow**
Deposits: ☒ None ☐ Mud ☐ Sludge ☐ Debris ☐ Grease
Silt Depth: (in.) Deposits Extent:
Infiltration: **None** Pipe Seal Cond: **Sound**

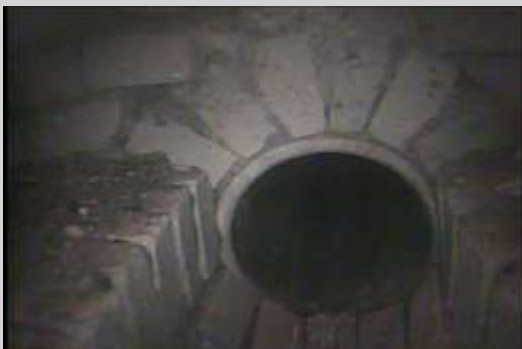
9 O'Clock Inflow

8 in. Circular Gravity Sewer
Pipe In @ 9 O'Clock

Pipe Height: **8.4** (in.) Rod and Bar (Angled)
Pipe Material: **Clay** ☐ Pipe Lined
Invert Depth: **8.92** (ft.) Flow Characteristics: **Slow**
Deposits: ☒ None ☐ Mud ☐ Sludge ☐ Debris ☐ Grease
Silt Depth: (in.) Deposits Extent:
Infiltration: **None** Pipe Seal Cond: **Sound**
